## Bernardsville Borough

### Introduction

The purpose of this report is to provide a comprehensive understanding of key, defining features within the subwatersheds throughout Bernardsville Borough. This involves gathering, organizing, and presenting information about existing conditions and infrastructure within each subwatershed. It aims to serve as a tool for informed decision-making, planning, and

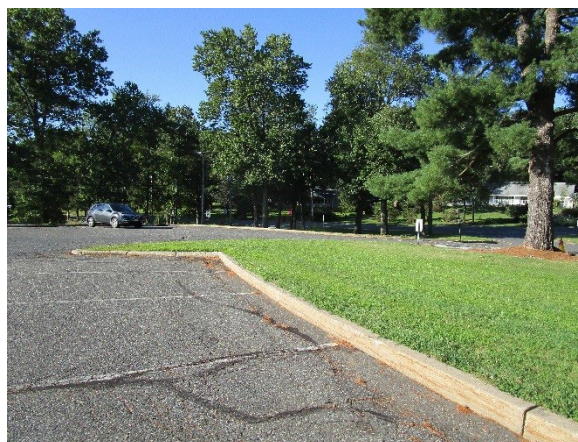
Rain gardens can be installed in parking lot islands to capture, treat, and infiltrate stormwater runoff from the parking lot. A section of parking spaces can be converted to porous asphalt to capture and infiltrate runoff from the parking lot as well. A rain barrel can be installed at the small greenhouse in the courtyard to capture runoff to be reused for watering the garden. A preliminary soil assessment suggests that more soil testing would be required before determining the soil's suitability for green infrastructure.

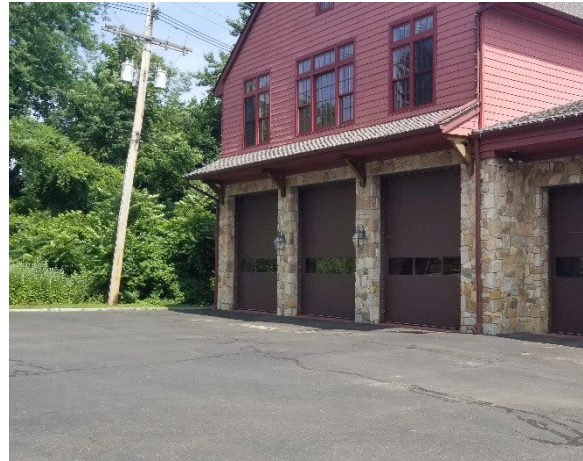
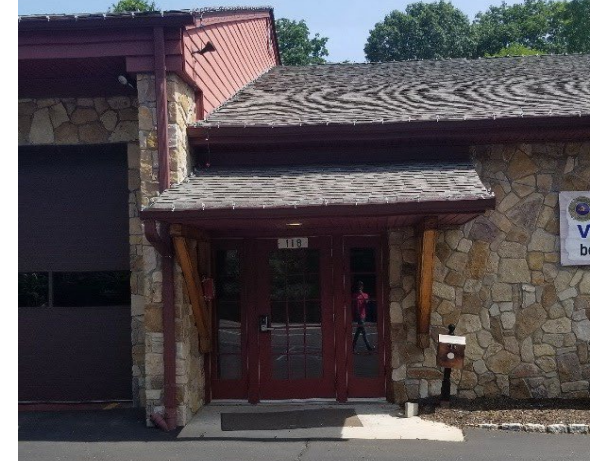
Cisterns can be installed at the northeast and west corners of the main building to capture and reuse stormwater. A downspout planter box can be installed next to the main entrance to capture and filter stormwater. A rain garden can be installed at the bottom of the hill to help manage stormwater causing erosion along the hill. Additional measures should be taken to stabilize the slope. A preliminary soil assessment suggests that more soil testing would be required before determining the soil's suitability for green infrastructure.

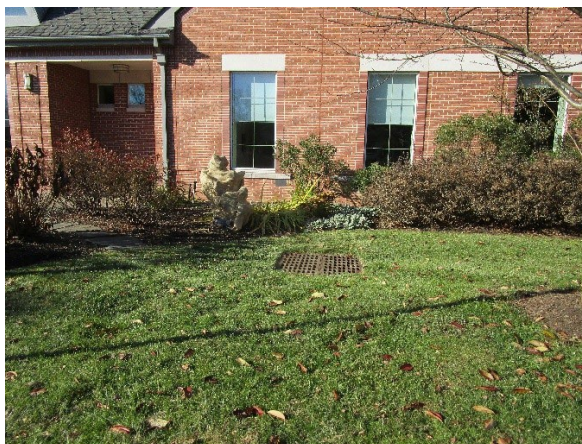
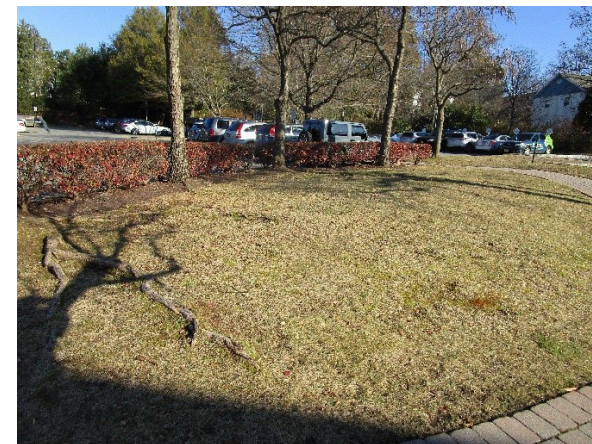
Downspout planter boxes can be installed alongside the northern side of the building to capture and filter stormwater. Pervious pavement can be installed in the parking spaces to the east to capture, treat, and infiltrate parking lot runoff. Rain gardens can be installed adjacent to parking spaces and downspouts to capture, treat, and infiltrate runoff from the parking lot and rooftop. A preliminary soil assessment suggests that the soils have suitable drainage characteristics for green infrastructure.

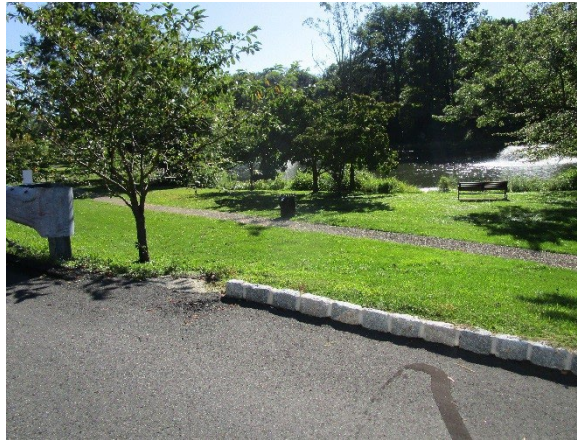
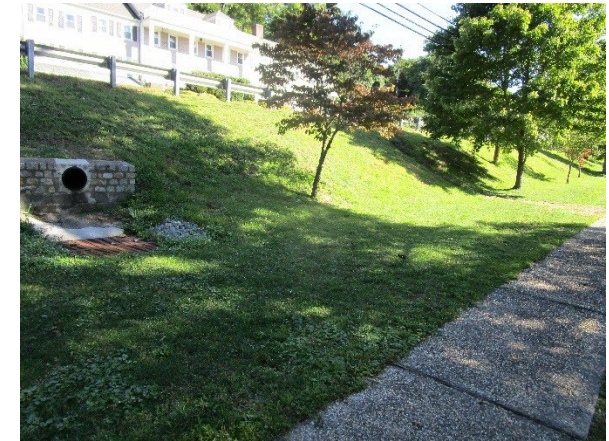
Pervious pavement can be installed in the parking lot to capture, treat, and infiltrate parking lot runoff. Two cisterns can be attached to the building to capture and filter stormwater runoff from the rooftop. Rain gardens can be installed adjacent to the roadways to capture, treat, and infiltrate runoff from the road. A preliminary soil assessment suggests that more soil testing would be required before determining the soil's suitability for green infrastructure.

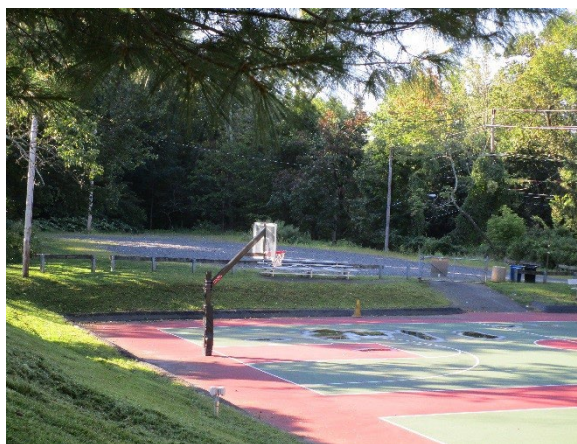
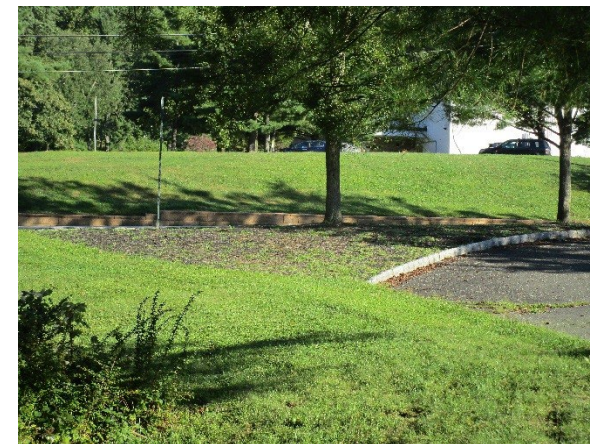
Two sections of parking spaces can be converted to pervious pavement to capture and infiltrate parking lot runoff. Sections of turfgrass adjacent to the parking lot can be converted to rain gardens to capture, treat, and infiltrate parking lot runoff. A preliminary soil assessment suggests that more soil testing would be required before determining the soil's suitability for green infrastructure.

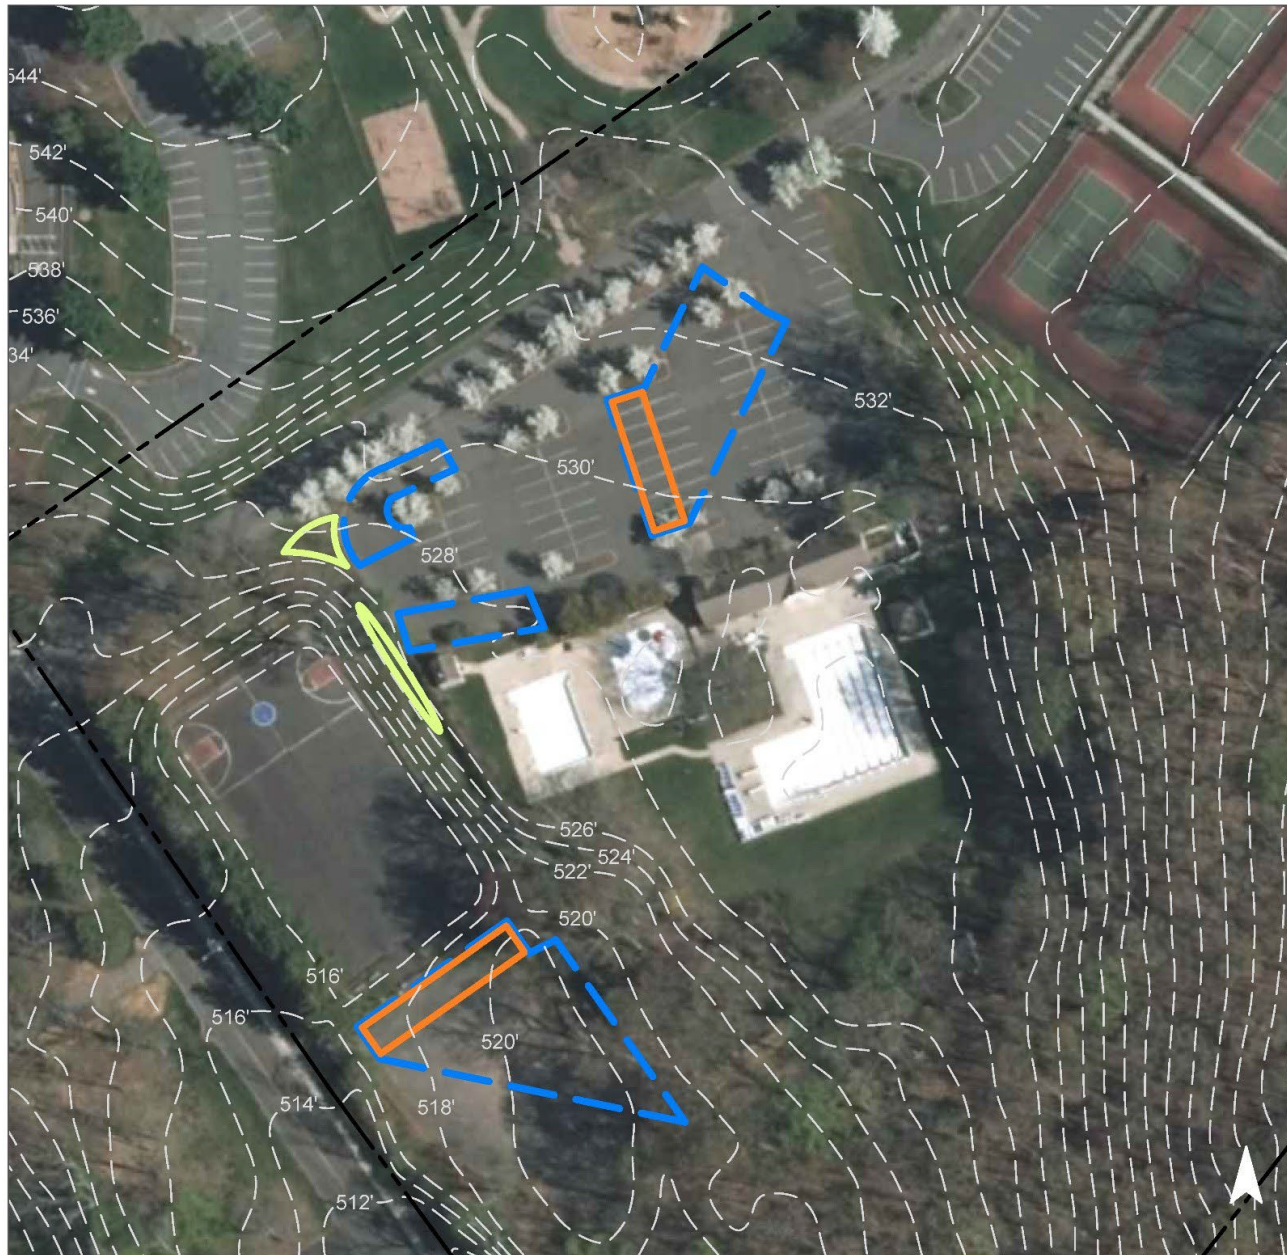
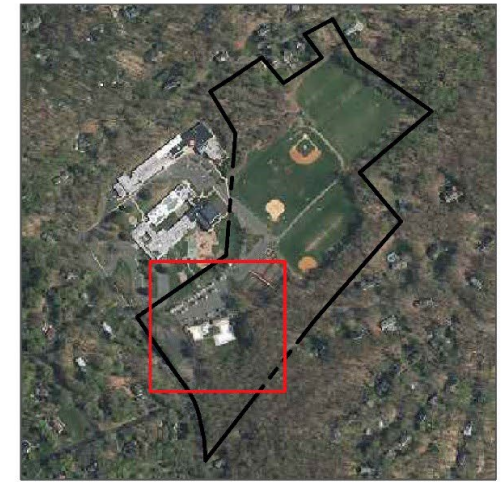
## Bernardsville Municipal Pool

Pervious pavement can be installed in the back parking lot to capture, treat, and infiltrate parking lot runoff. Downspout planter boxes can be installed at the bases of the downspouts connected to the support beams at the southeast corner of the building to capture and filter stormwater. A preliminary soil assessment suggests that more soil testing would be required before determining the soil's suitability for green infrastructure.

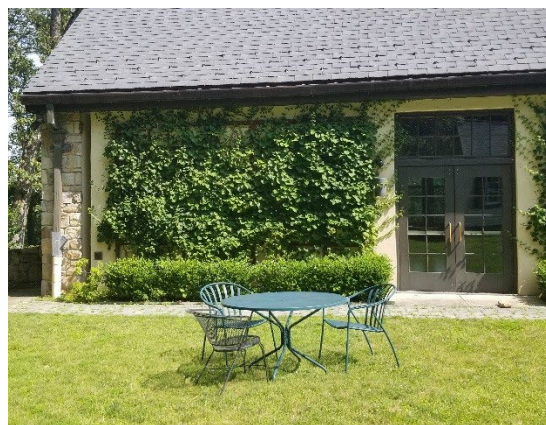
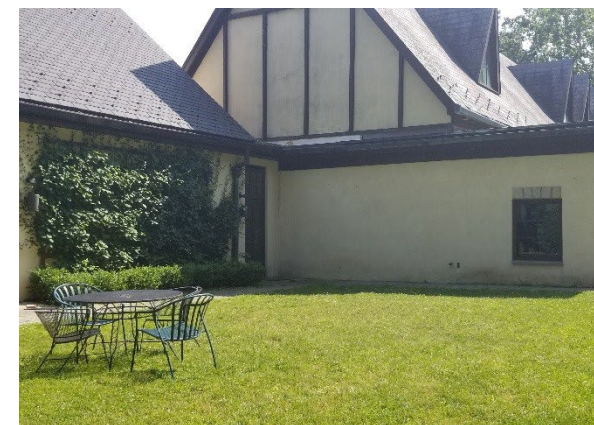
Rain gardens can be installed at the corner of the sidewalk and adjacent to the shed to the north of the church to capture, treat, and infiltrate rooftop runoff. Downspout planter boxes can be installed at the northeast corner of the building to capture and filter stormwater. A preliminary soil assessment suggests that more soil testing would be required before determining the soil's suitability for green infrastructure.

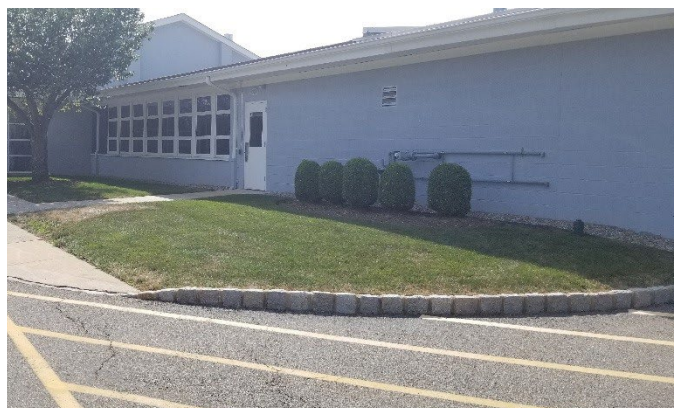
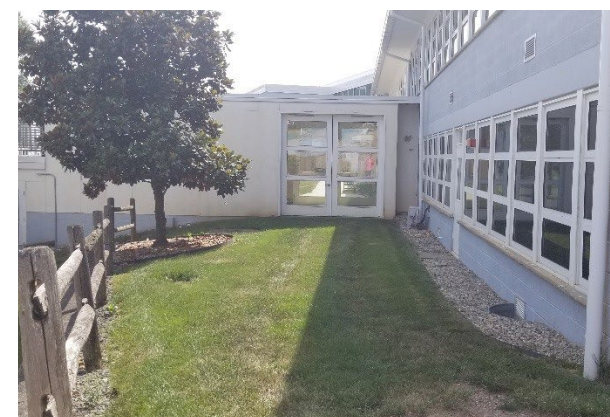
Rain gardens can be installed in the turfgrass to capture, treat, and infiltrate rooftop and parking lot runoff. Downspout planter boxes can be installed in the courtyard to capture and filter stormwater. A preliminary soil assessment suggests that more soil testing would be required before determining the soil's suitability for green infrastructure.

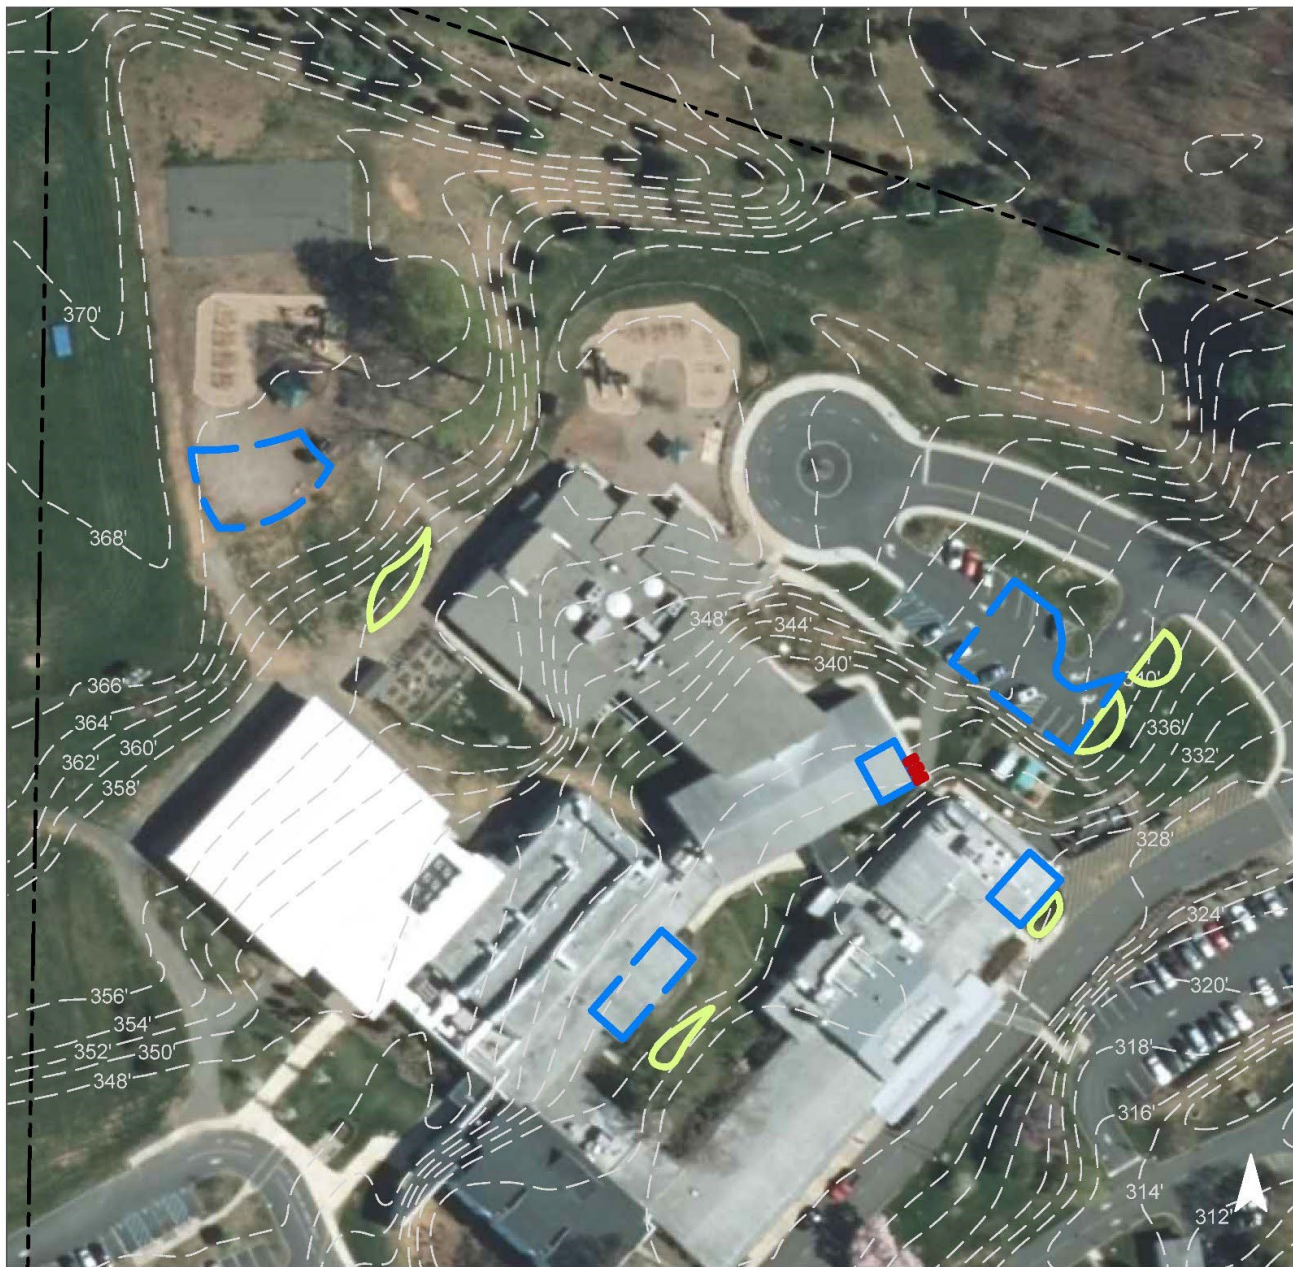
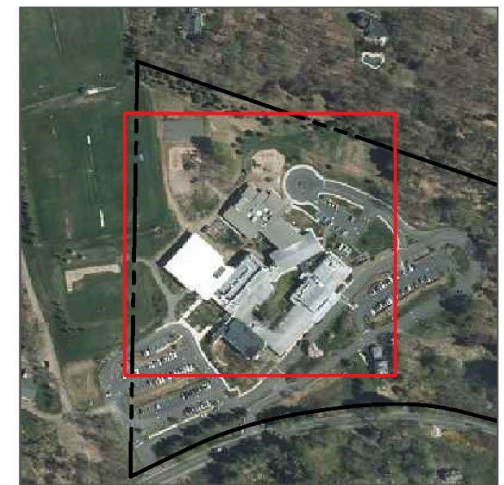
## Far Hills Country Day School

A rain garden can be installed in the turfgrass court to capture, treat, and infiltrate parking lot runoff. Pervious pavement can be installed in the parking spaces to capture, treat, and infiltrate parking lot runoff. A preliminary soil assessment suggests that more soil testing would be required before determining the soil's suitability for green infrastructure.

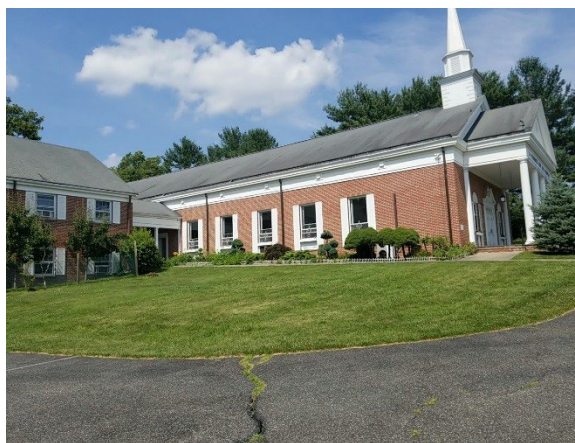
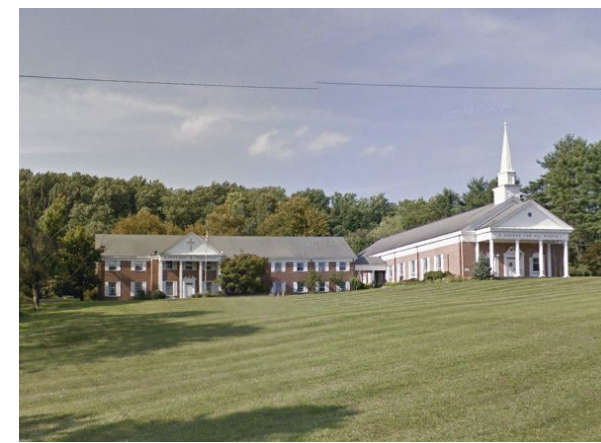
Rain gardens can be installed in the courtyard in the corner of the building and adjacent to the parking lot south of the building to capture, treat, and infiltrate rooftop and parking lot runoff. Pervious pavement can be installed in the small area of parking spaces in front and in the larger parking lot in the rear of the building to capture, treat, and infiltrate parking lot runoff. A preliminary soil assessment suggests that more soil testing would be required before determining the soil's suitability for green infrastructure.

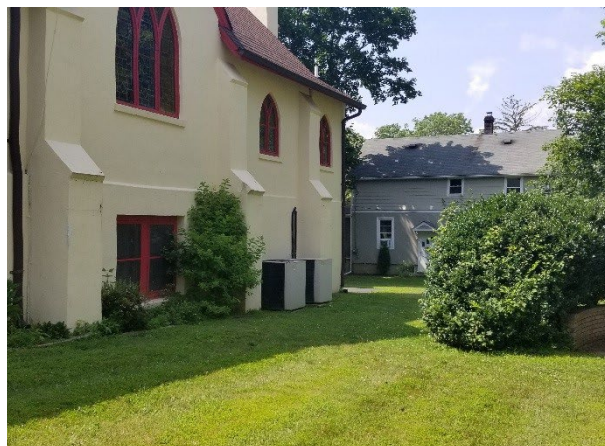
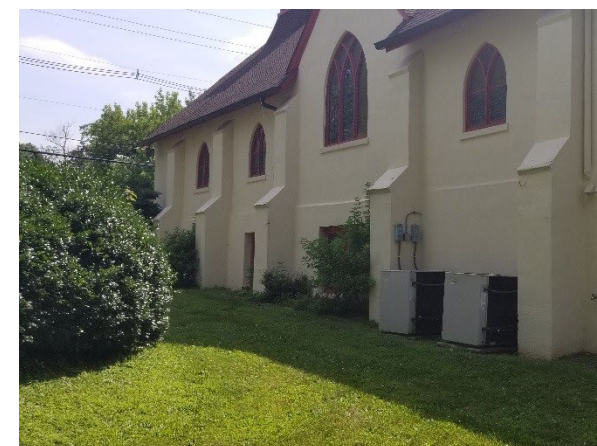
A rain garden can be installed on the eastern side of the church to capture, treat, and infiltrate rooftop runoff. A downspout planter box can be installed at the northeast corner of the church to capture and filter stormwater. Pervious pavement can be installed in the parking spaces north of the building to capture, treat, and infiltrate parking lot runoff. A preliminary soil assessment suggests that more soil testing would be required before determining the soil's suitability for green infrastructure.

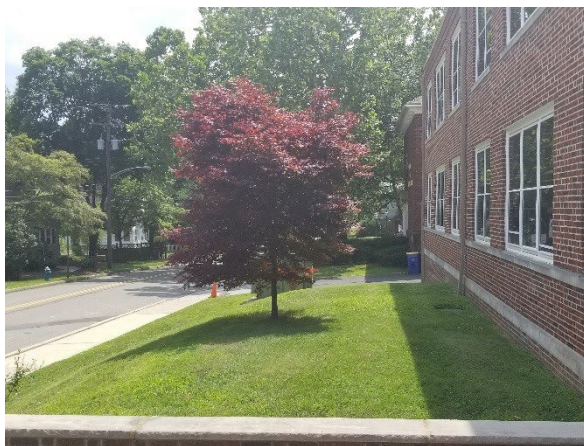
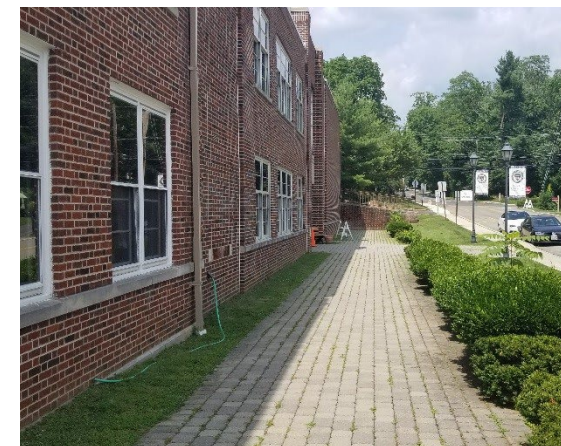
Rain gardens can be installed on either side of the red tree shown to the southeast of the school and along the southeast corner of the tennis court to capture, treat, and infiltrate rooftop and pavement runoff. Downspout planter boxes can be installed to the right of the main entrance to capture and filter stormwater. A preliminary soil assessment suggests that more soil testing would be required before determining the soil's suitability for green infrastructure.

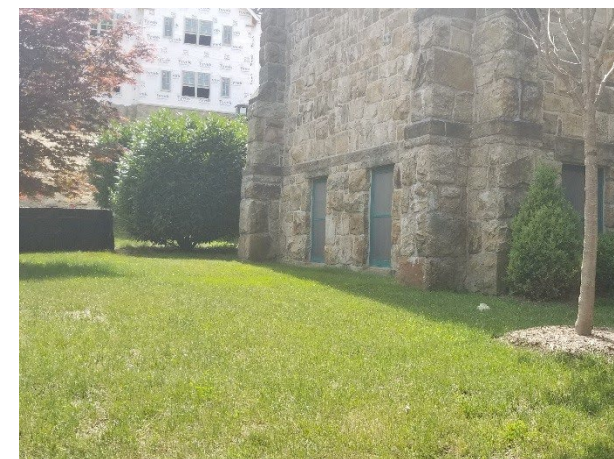
A rain garden can be installed along the southeast side of the church and at the bottom of a hill on the property to capture, treat, and infiltrate parking lot and rooftop runoff. A preliminary soil assessment suggests that more soil testing would be required before determining the soil's suitability for green infrastructure.

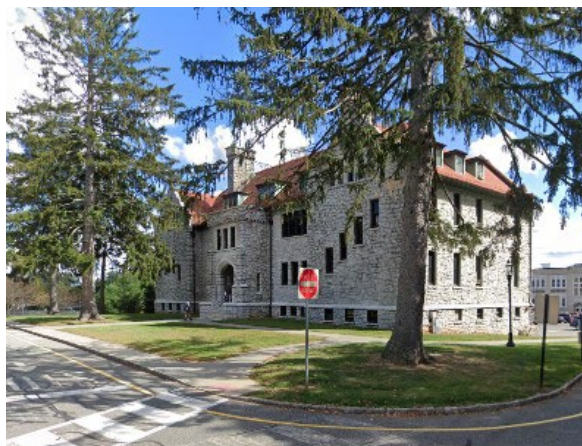
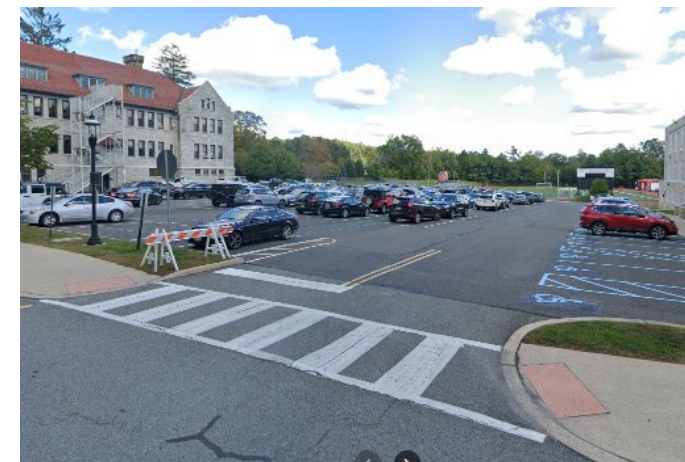
Rain gardens can be installed in multiple grass areas around the property to capture, treat, and infiltrate the stormwater runoff from rooftops, walkways, road, and driveways. Some of these gardens require curb cuts and trench drains to intercept and redirect runoff to the gardens. Existing parking spaces in the northern and southern parking lots can be converted into pervious pavement to capture and infiltrate the stormwater runoff from the asphalt. A preliminary soil assessment suggests that the soils have suitable drainage characteristics for green infrastructure.
