## Mine Hill Township

### Introduction

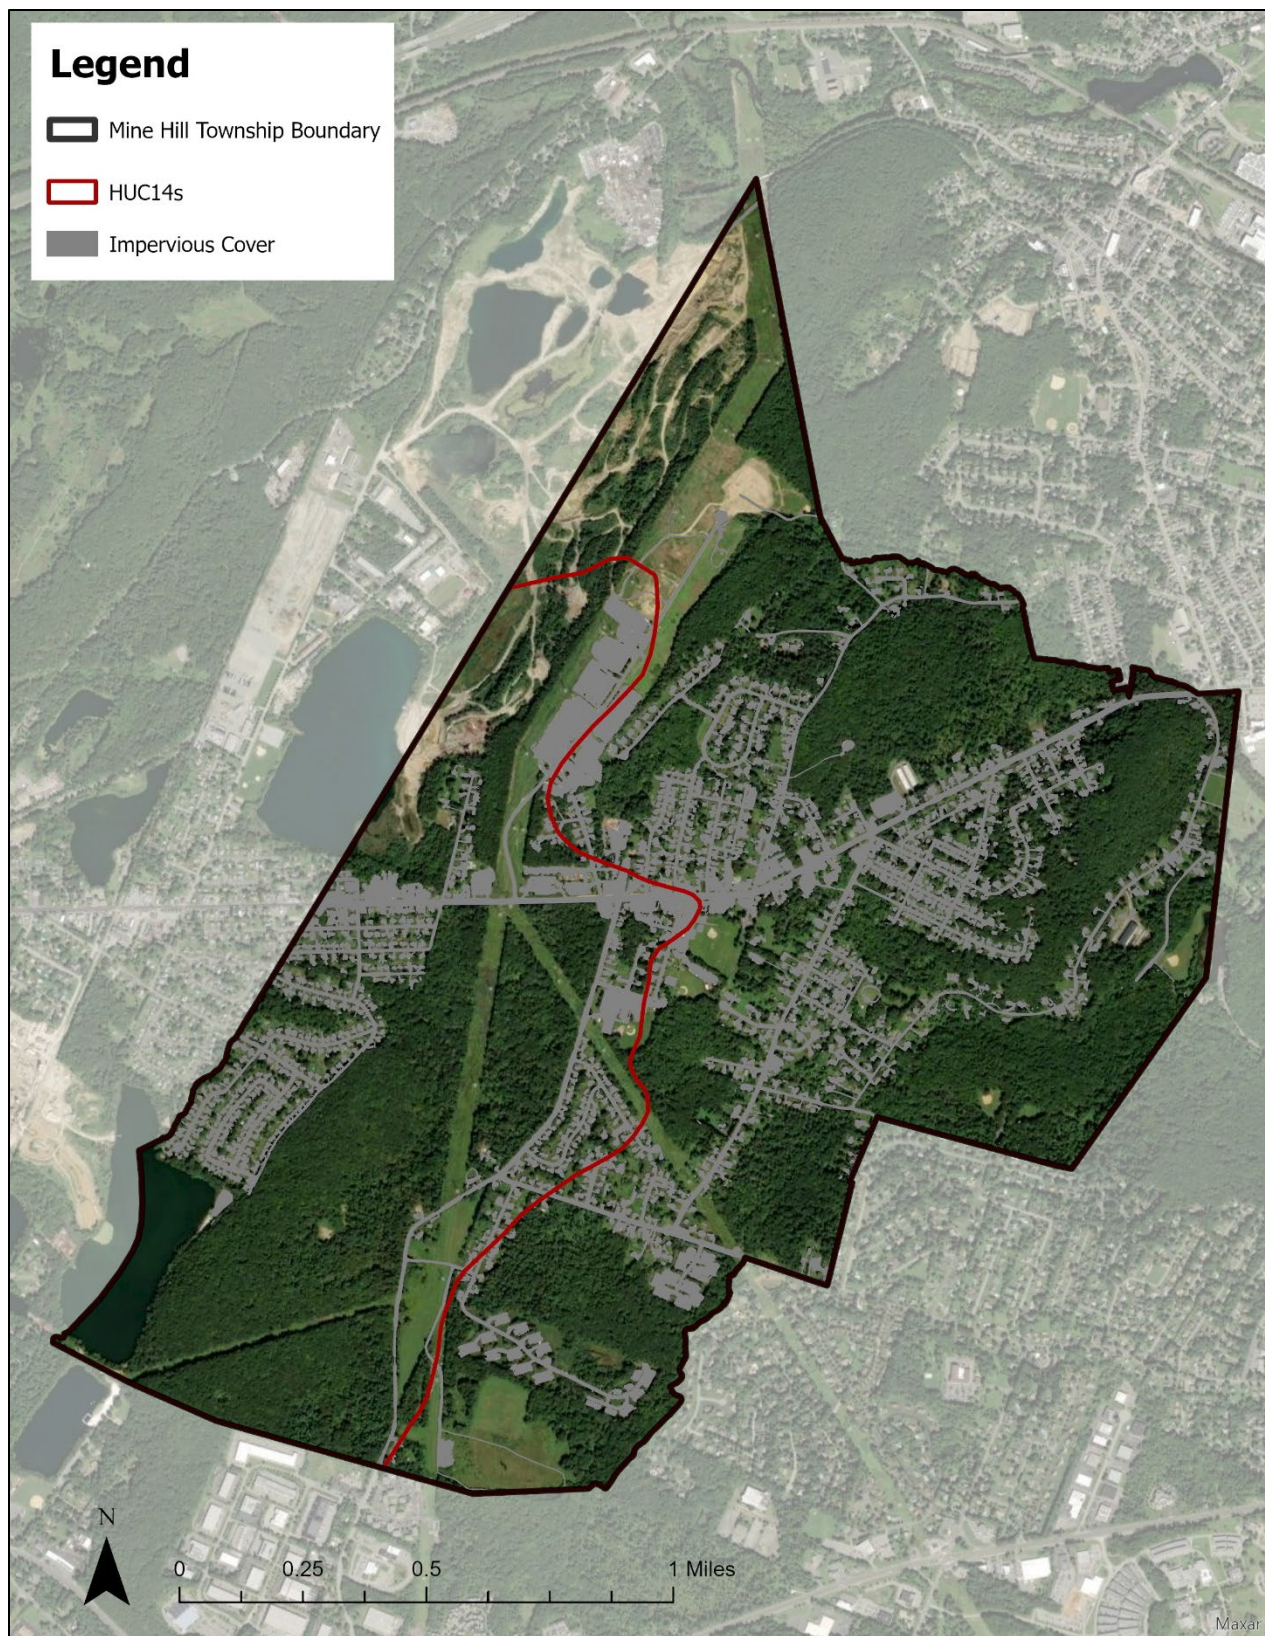
**Figure 4: Impervious Cover in Mine Hill Township**

NJDEP's Open Data impervious surface GIS data layer depicts surfaces throughout Mine Hill Township that have been covered with materials that are highly resistant to infiltration by water, rendering them impervious. These surfaces include rooftops, roadways, sidewalks, and other paved areas. These impervious cover values were used to estimate the impervious coverage for Mine Hill Township. Based upon the NJDEP impervious surface data, Mine Hill Township has impervious cover totaling 16.5%. Table 3 shows impervious cover for each HUC14. The extent of the impervious cover in Mine Hill Township is shown in Figure 4.

Based upon this information, Mine Hill Township’s impervious cover percentage would suggest that its waterways are primarily impacted and most likely contributing to not meeting the state’s surface water quality standards.

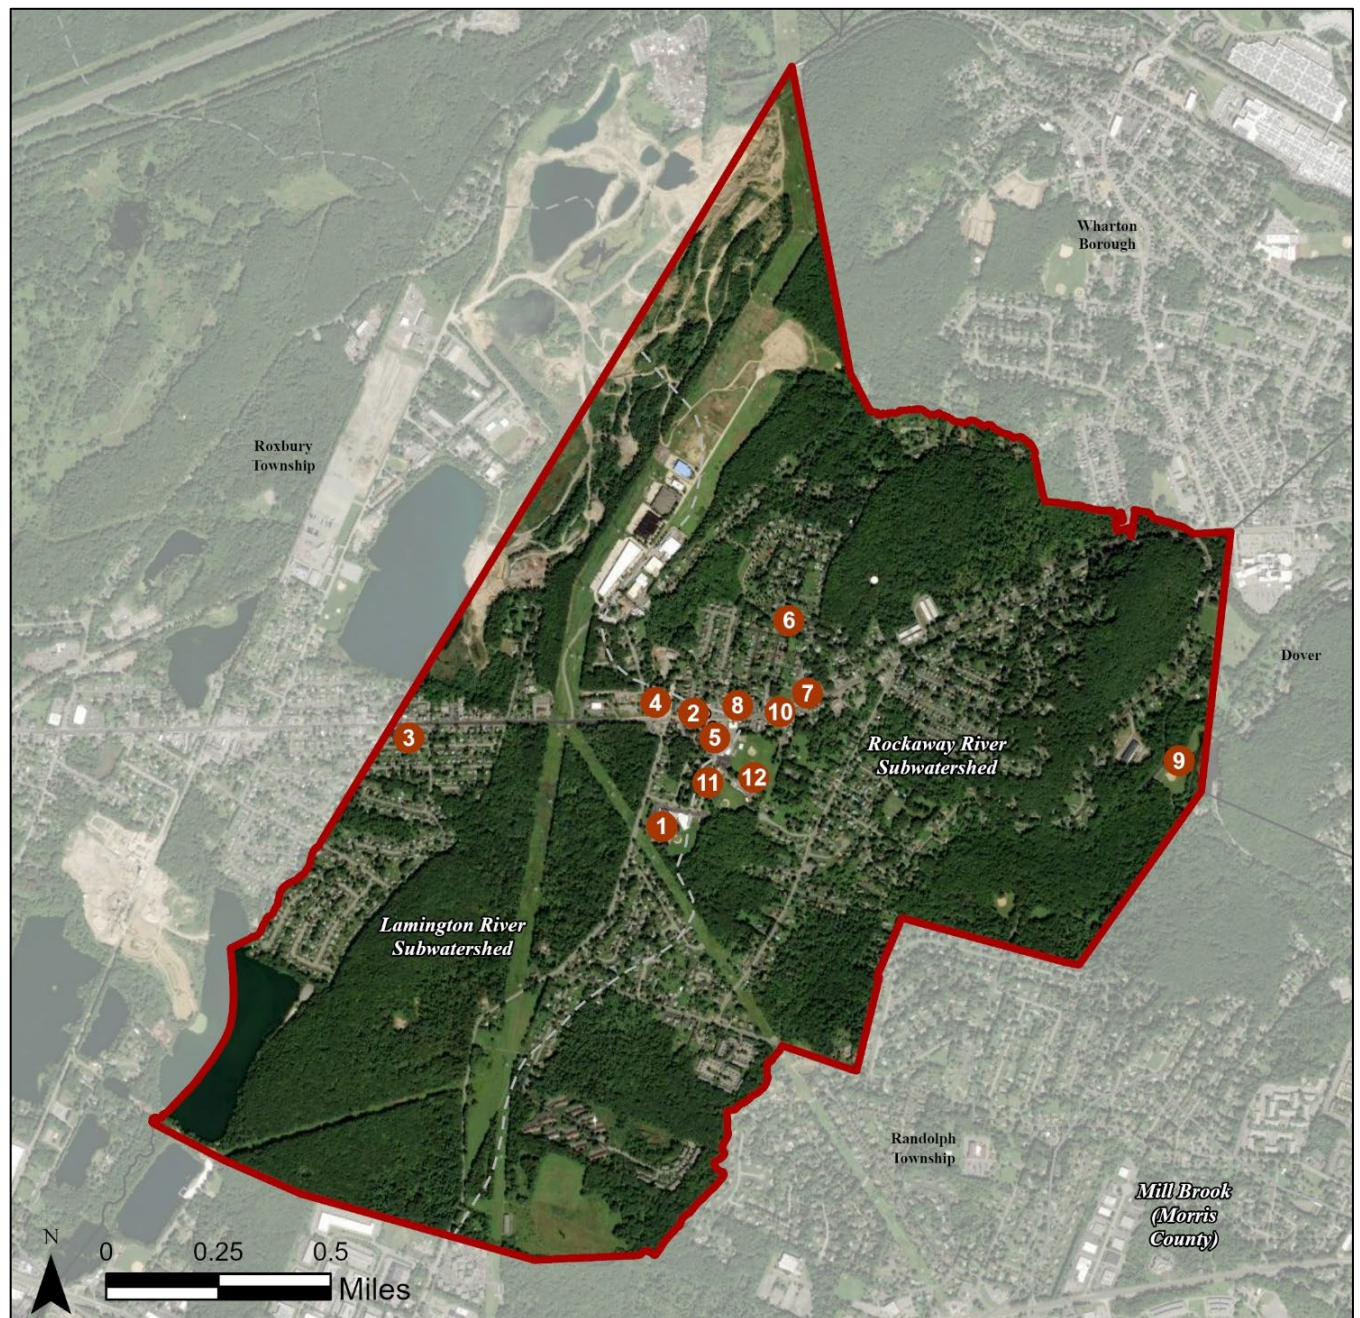
**Figure 11: Sites with Green Infrastructure Opportunities in Mine Hill Township**

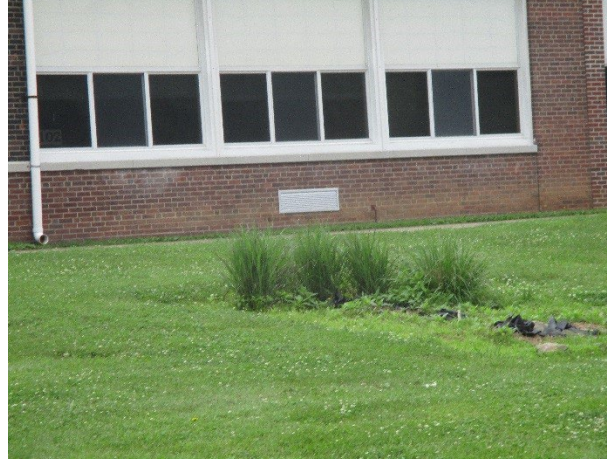
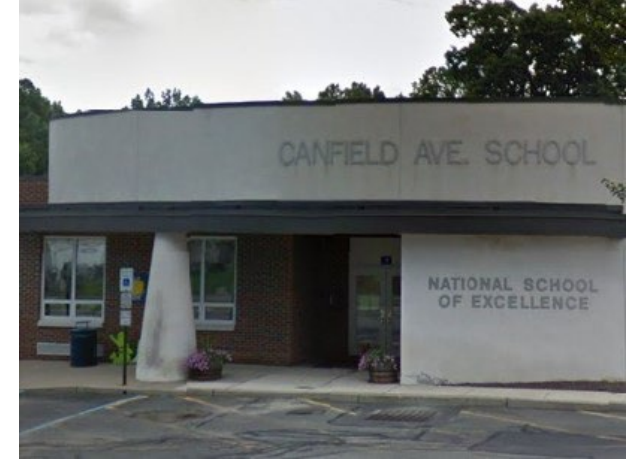
**Block and Lot:** Block 1401, Lot 1

A rain garden can be installed near the disconnected downspouts to capture, treat, and infiltrate rooftop runoff. A preliminary soil assessment suggests that more soil testing would be required before determining the soil's suitability for green infrastructure.

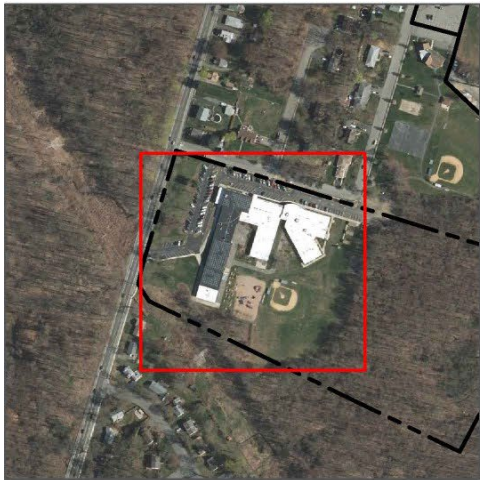
**Canfield Avenue  
Elementary School**

-

bioretention system
-

drainage area
-

property line
-

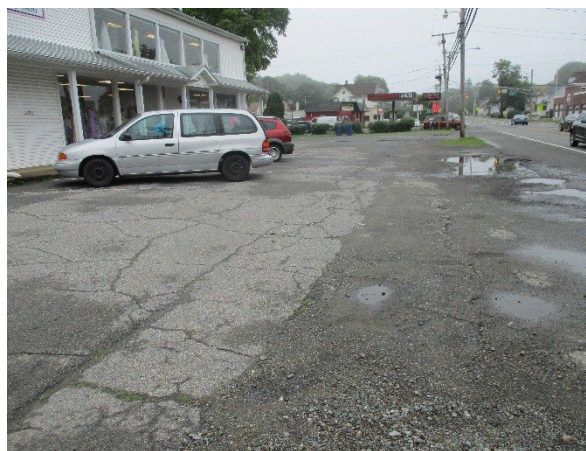
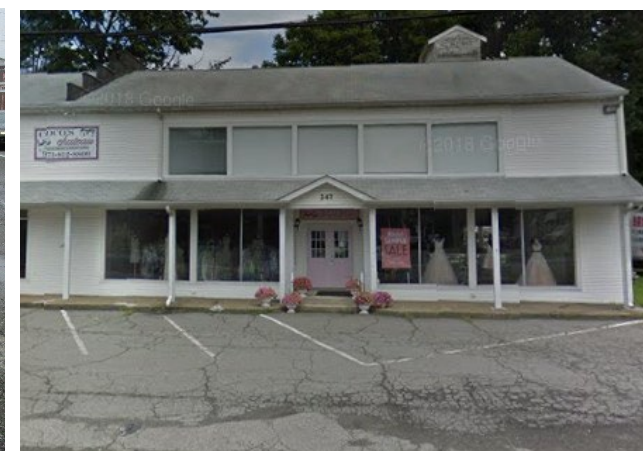
**Block and Lot:** Block 805, Lot 1

Pervious pavement can be installed on a parking strip south of the building to capture and infiltrate stormwater. A preliminary soil assessment suggests that the soils have suitable drainage characteristics for green infrastructure.

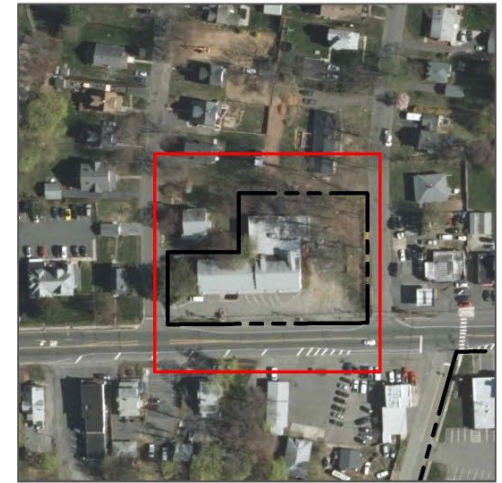
## Coco's Chateau

pervious pavement
-

drainage area
-

property line
-

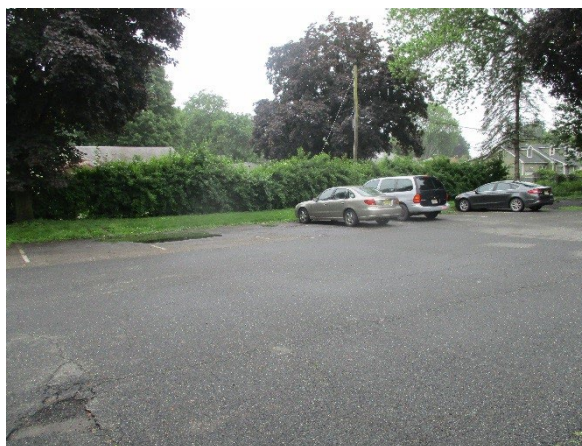
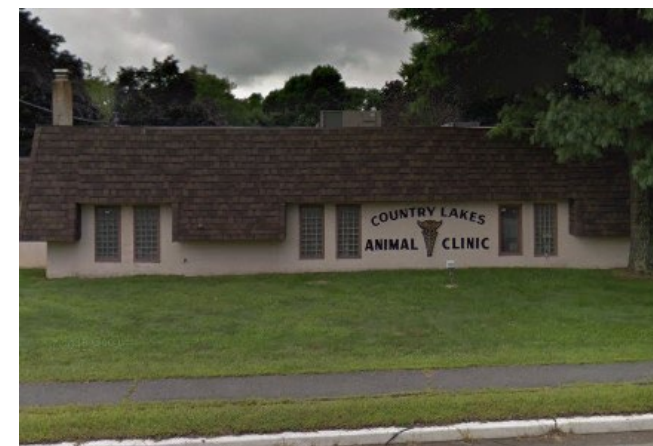
**Block and Lot:** Block 404, Lot 3-4,8

Parking spaces south of the building can be replaced with pervious pavement to capture and infiltrate stormwater. A preliminary soil assessment suggests that more soil testing would be required before determining the soil's suitability for green infrastructure.

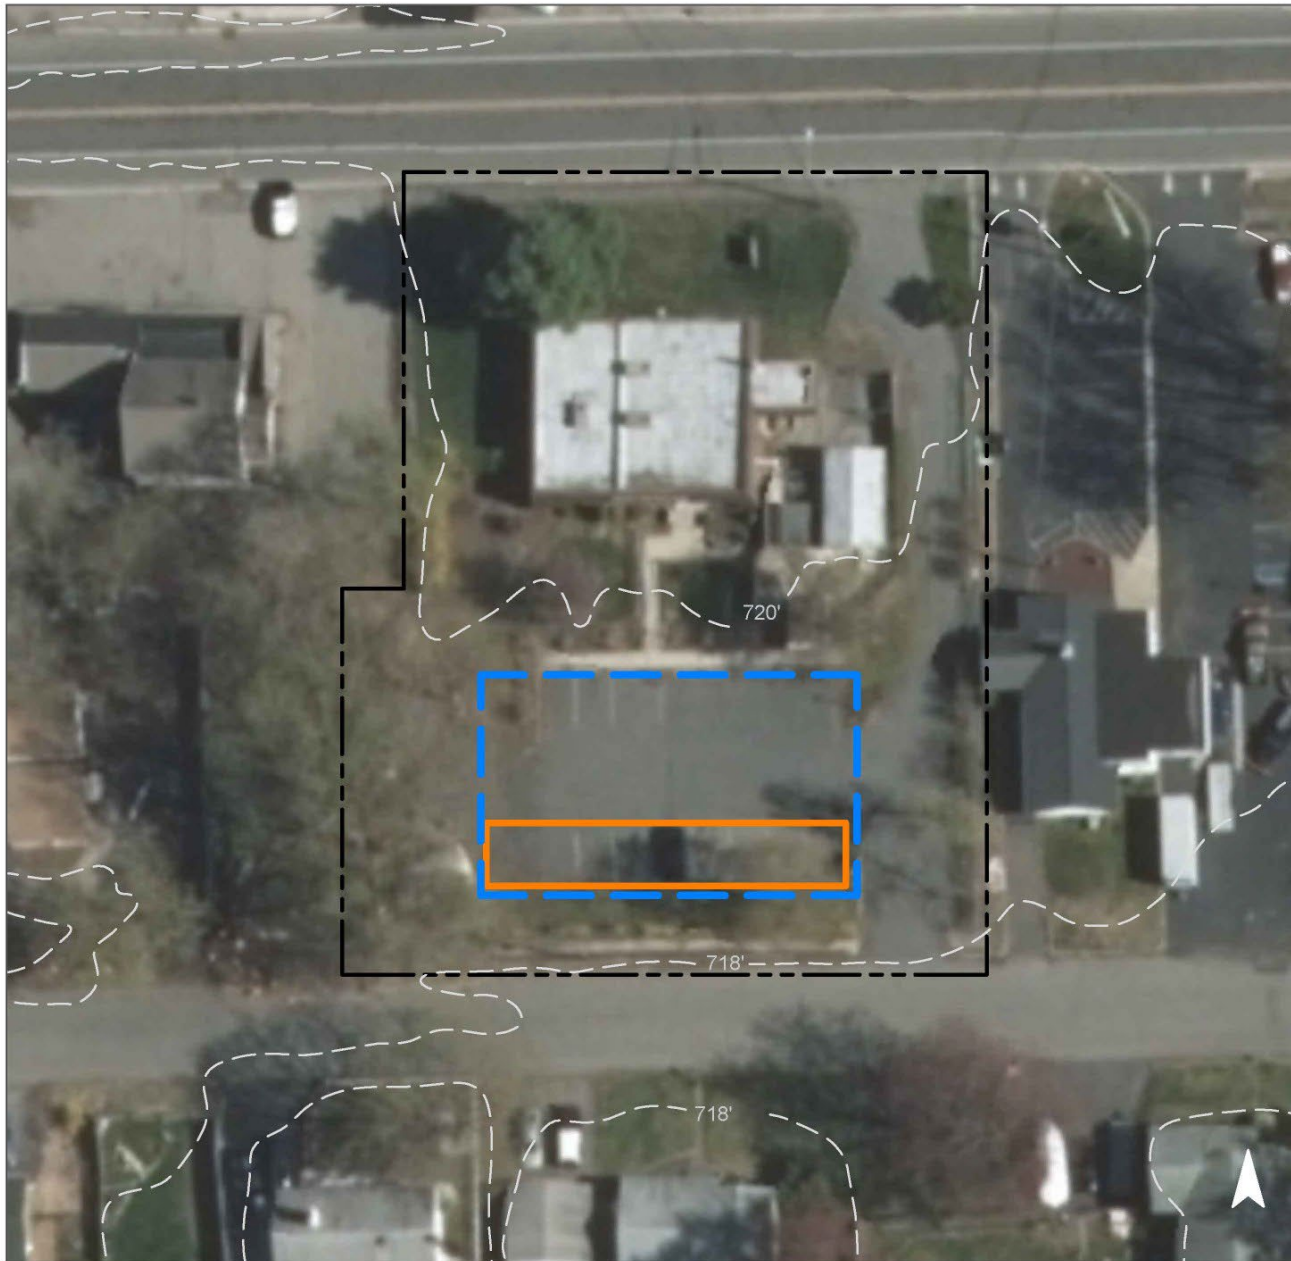
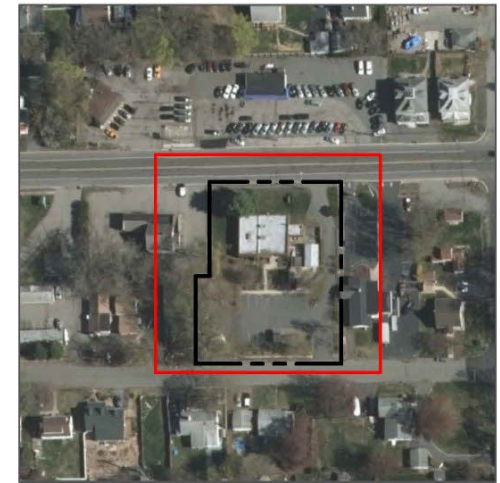
## Country Lakes Animal Clinic

pervious pavement
-

drainage area
-

property line
-

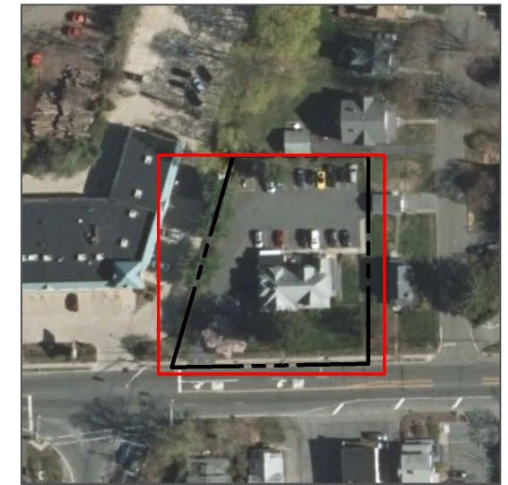
## Hodes Veterinary Group

pervious pavement
-

drainage area
-

property line
-

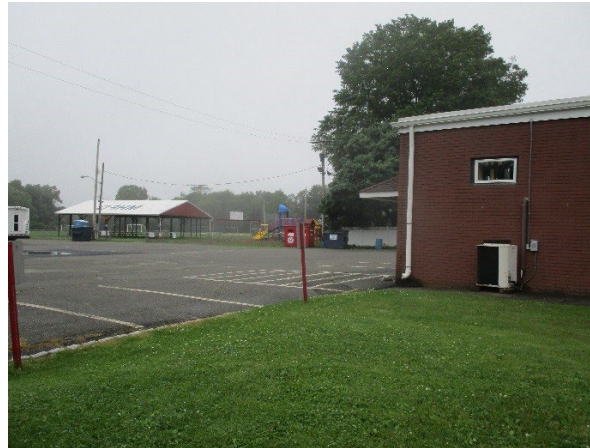
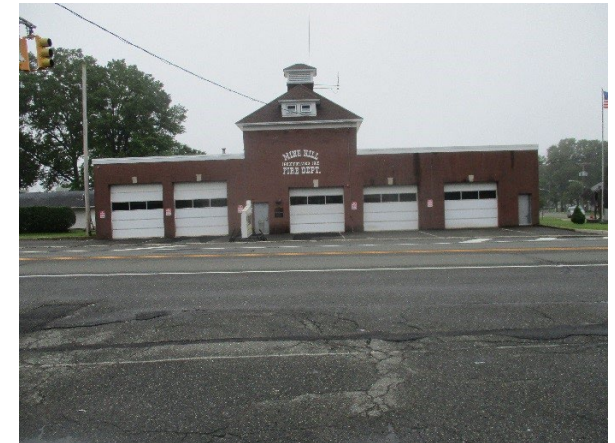
**Block and Lot:** Block 1304, Lot 17

A rain garden can be installed on the west side of the building to capture, treat, and infiltrate rooftop runoff. Pervious pavement can be installed on the south parking strip to store stormwater runoff and allow it to slowly infiltrate into the ground. A cistern can be installed on the east side of the building near a disconnected downspout so the water can be used for watering gardens, washing vehicles, or for other non-potable uses. A preliminary soil assessment suggests that more soil testing would be required before determining the soil's suitability for green infrastructure.

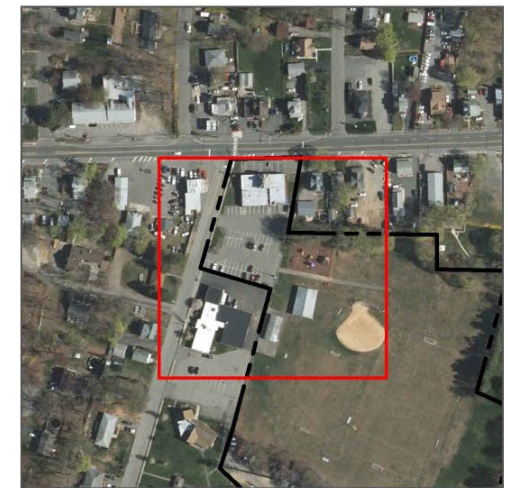
## Mine Hill Fire Department

- bioretention system
- pervious pavement
- rainwater harvesting
- drainage area
- property line
- 2015 Aerial: NJOIT, OGIS

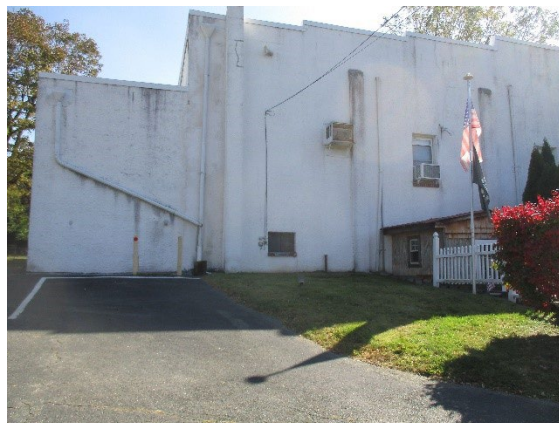
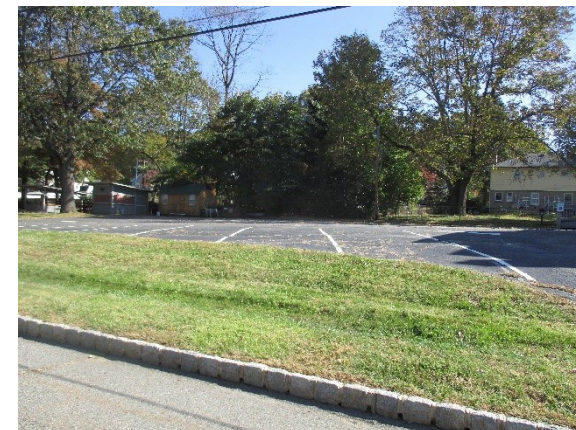
**Block and Lot:** Block 802, Lot 1

Half of the building's rooftop runoff and part of the parking lot runoff, can be treated with pervious pavement in the east strip of the parking lot. A preliminary soil assessment suggests that more soil testing would be required before determining the soil's suitability for green infrastructure.

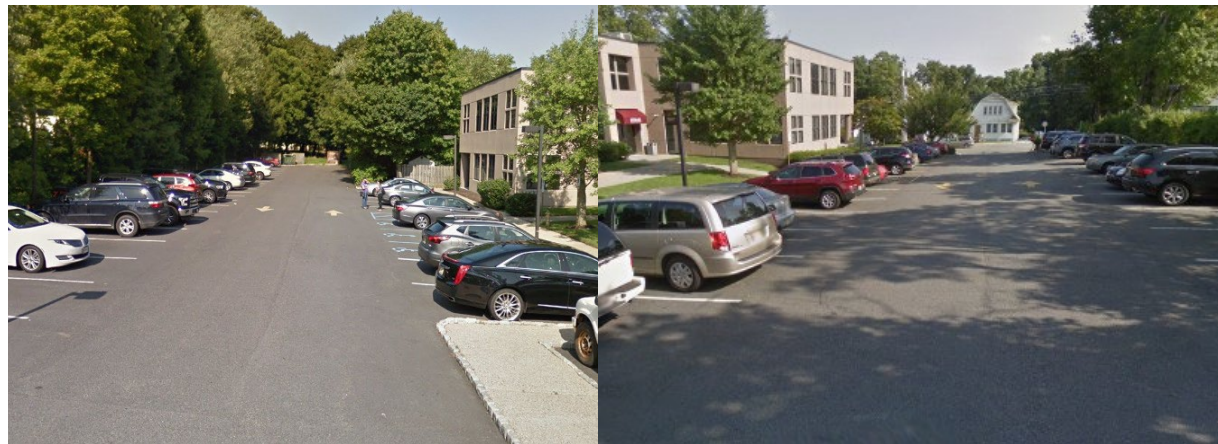
**Block and Lot:** Block 1302, Lot 2

Existing parking spaces to the north and west of the building can be converted into pervious pavement to capture and infiltrate the stormwater runoff from the parking lot. A trench drain may be required. A preliminary soil assessment suggests that the soils have suitable drainage characteristics for green infrastructure.

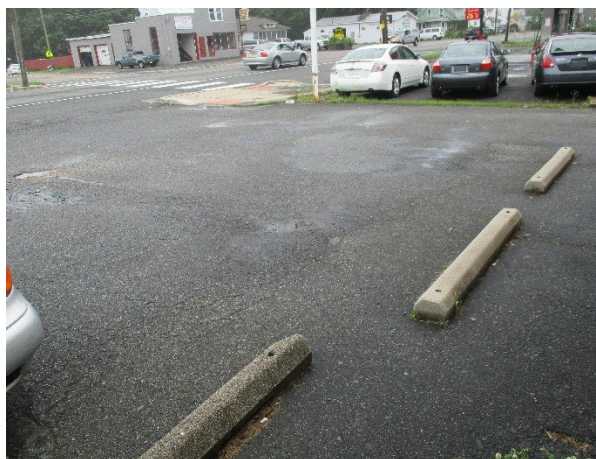
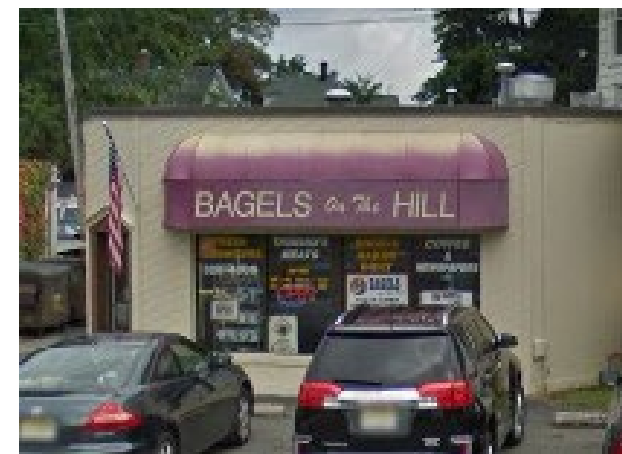
**Block and Lot:** Block 804, Lot 23

Pervious pavement can be installed south of the building to store stormwater runoff and allow it to slowly infiltrate into the ground. A preliminary soil assessment suggests that the soils have suitable drainage characteristics for green infrastructure.

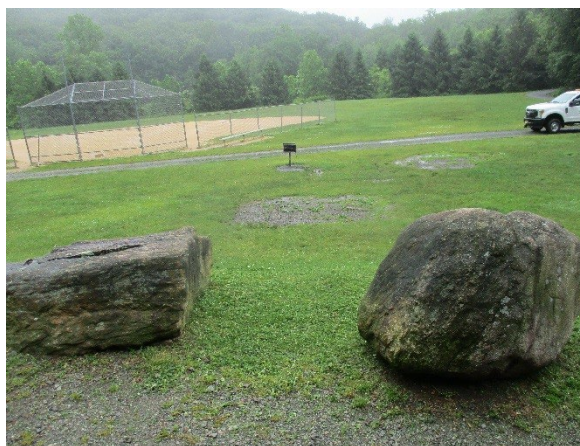
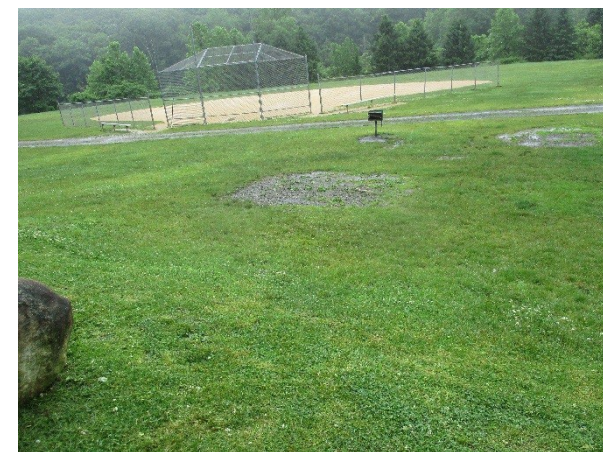
**Block and Lot:** Block 2101, Lot 1

A rain garden can be installed in the turfgrass area on the north side of the park to capture, treat, and infiltrate stormwater runoff from the parking/roadway area. A preliminary soil assessment suggests that more soil testing would be required before determining the soil's suitability for green infrastructure.

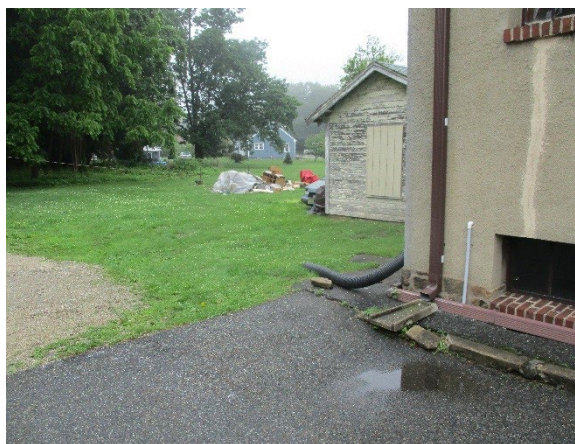
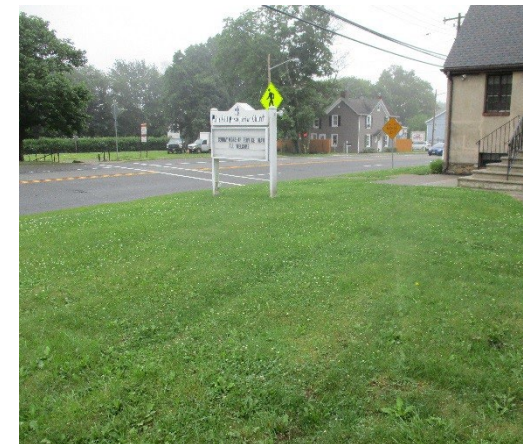
**Block and Lot:** Block 8002, Lot 17-18

Rain gardens can be installed on the north, southeast, and south sides of the building near disconnected downspouts to capture, treat, and infiltrate rooftop runoff. A preliminary soil assessment suggests that the soils have suitable drainage characteristics for green infrastructure.

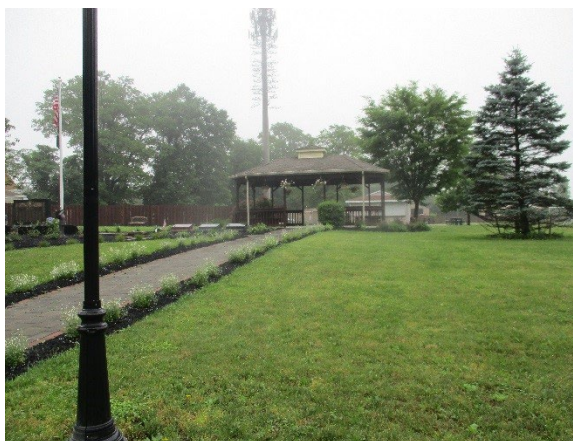
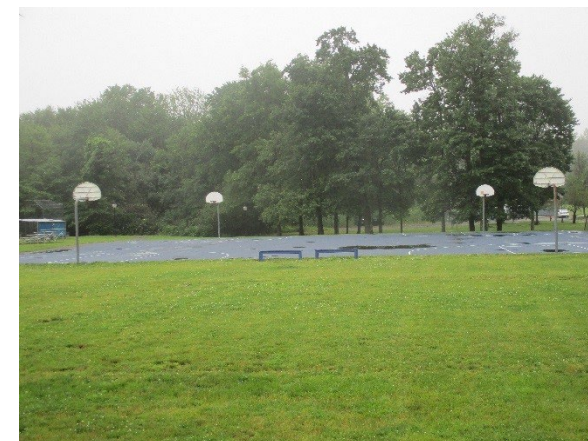
**Block and Lot:** Block 1304, Lot 13-14

A rain garden can be installed south of the gazebo to capture, treat, and infiltrate rooftop runoff. Pervious pavement can be installed on the basketball court to store stormwater runoff and allow it to slowly infiltrate into the ground. A preliminary soil assessment suggests that more soil testing would be required before determining the soil's suitability for green infrastructure.

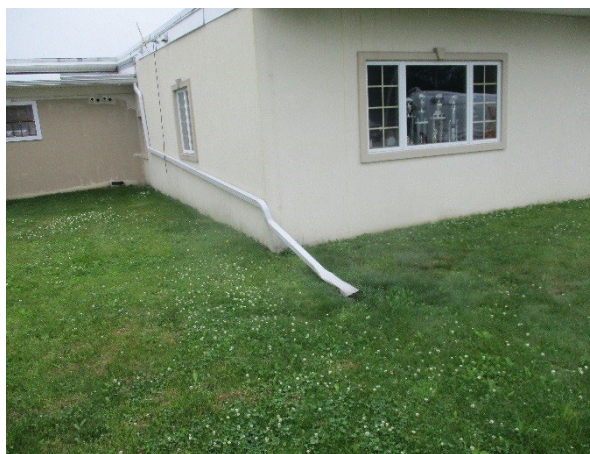
**Block and Lot:** Block 1304, Lot 16

A rain garden can be installed in the turfgrass area near the building to capture, treat, and infiltrate rooftop runoff. A preliminary soil assessment suggests that more soil testing would be required before determining the soil's suitability for green infrastructure.
