## **Hamilton Township (Mercer County) Stormwater Inlet & Catch Basin Assessment Summary 2026: Snow Zone F**

Developed by the Rutgers Cooperative Extension Water Resources Program  
Funded by Hamilton Township, Mercer County, New Jersey  
September 18, 2026

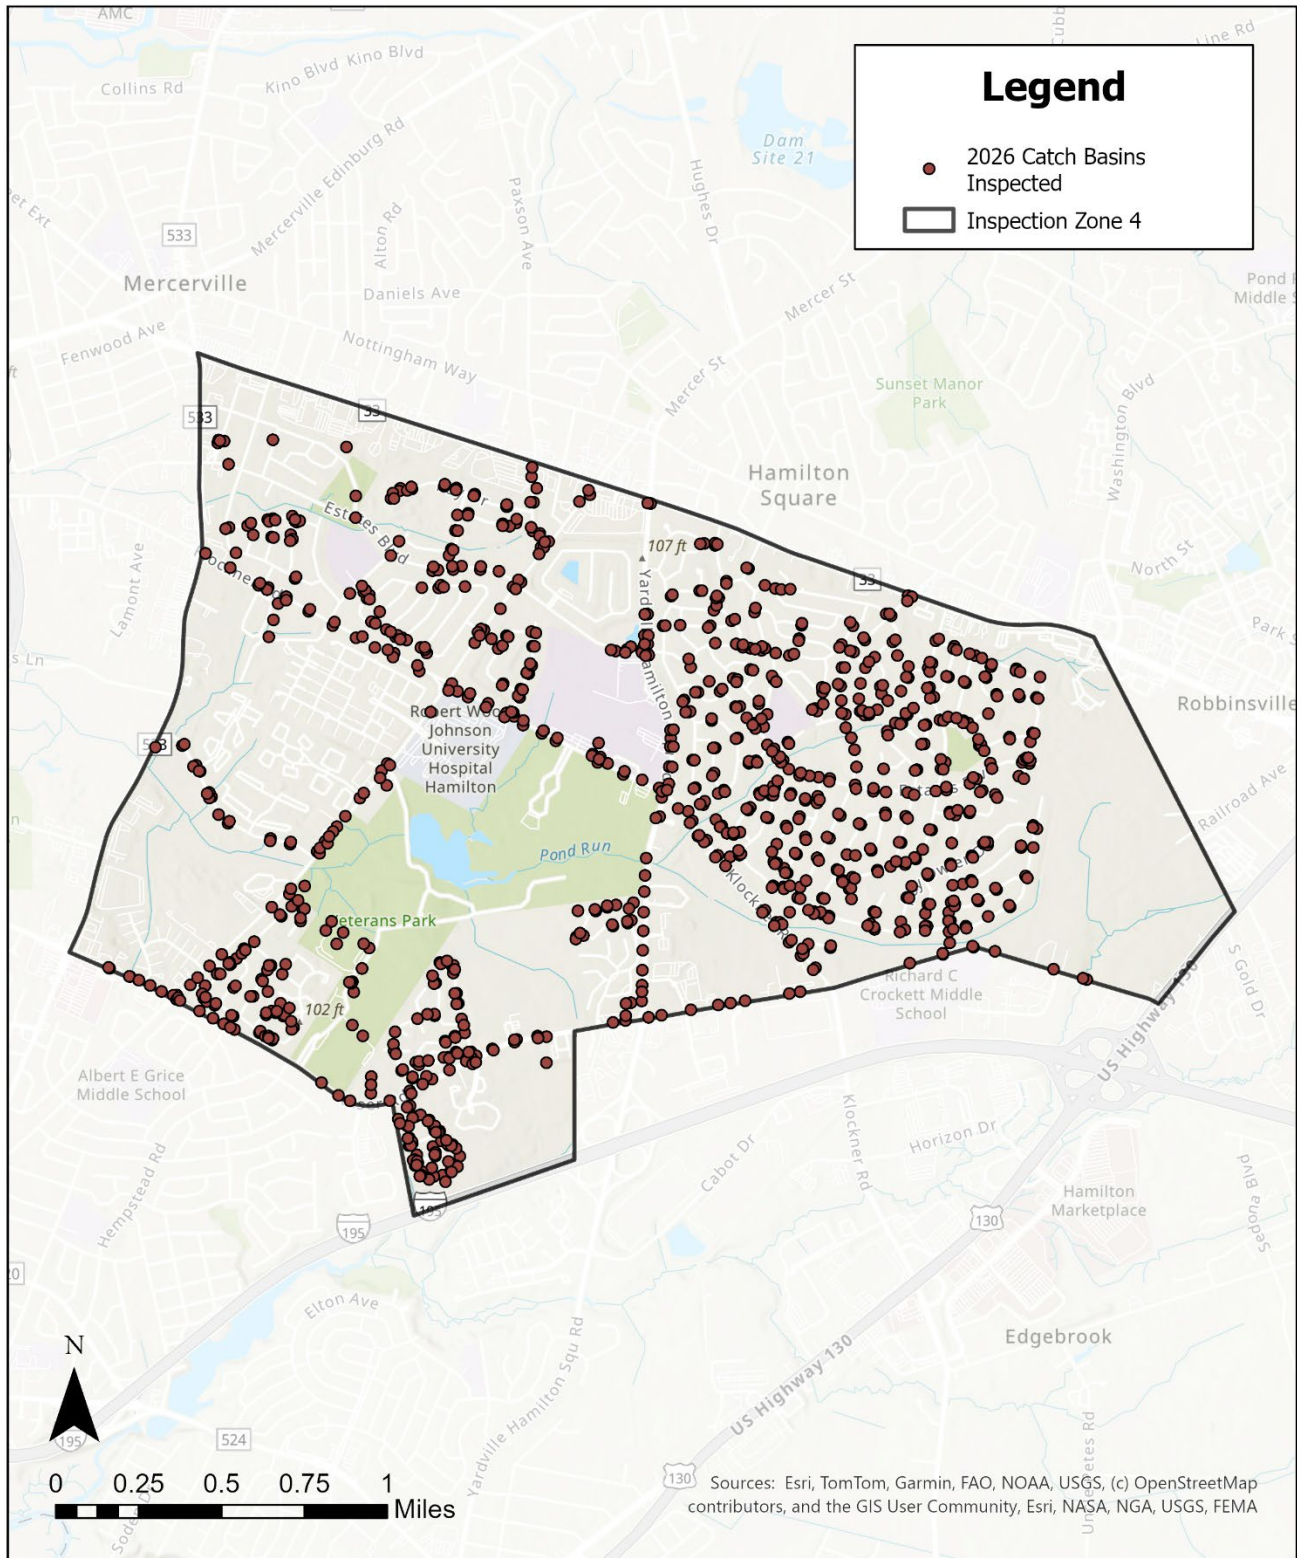
# Hamilton Catch Basin Inspection 2026: Snow Zone F

A total of 1,132 catch basins were inspected in 2026 in Snow Zone F by the RCE Water Resources Program and DPW combined as of this report. This is out of 7,292 Hamilton Township-owned or operated stormwater catch basins, including catch basins in the right of way, on municipally owned property, and in stormwater related easements. Of the 1,132 catch basins inspected in Snow Zone F, 74 were already inspected by the DPW, 1,021 were successfully inspected by the RCE Water Resources Program, 32 were reported not to exist, three (3) were reported to not be catch basins, one (1) is suspected to be a duplicate of another point, and one (1) was otherwise not found. There were an additional 117 catch basins that were inaccessible primarily due to either being on residential or commercial property. Tables summarizing the site inspections for the catch basins that were inaccessible, not found, or reported to not be catch basins are included in Attachment 2.

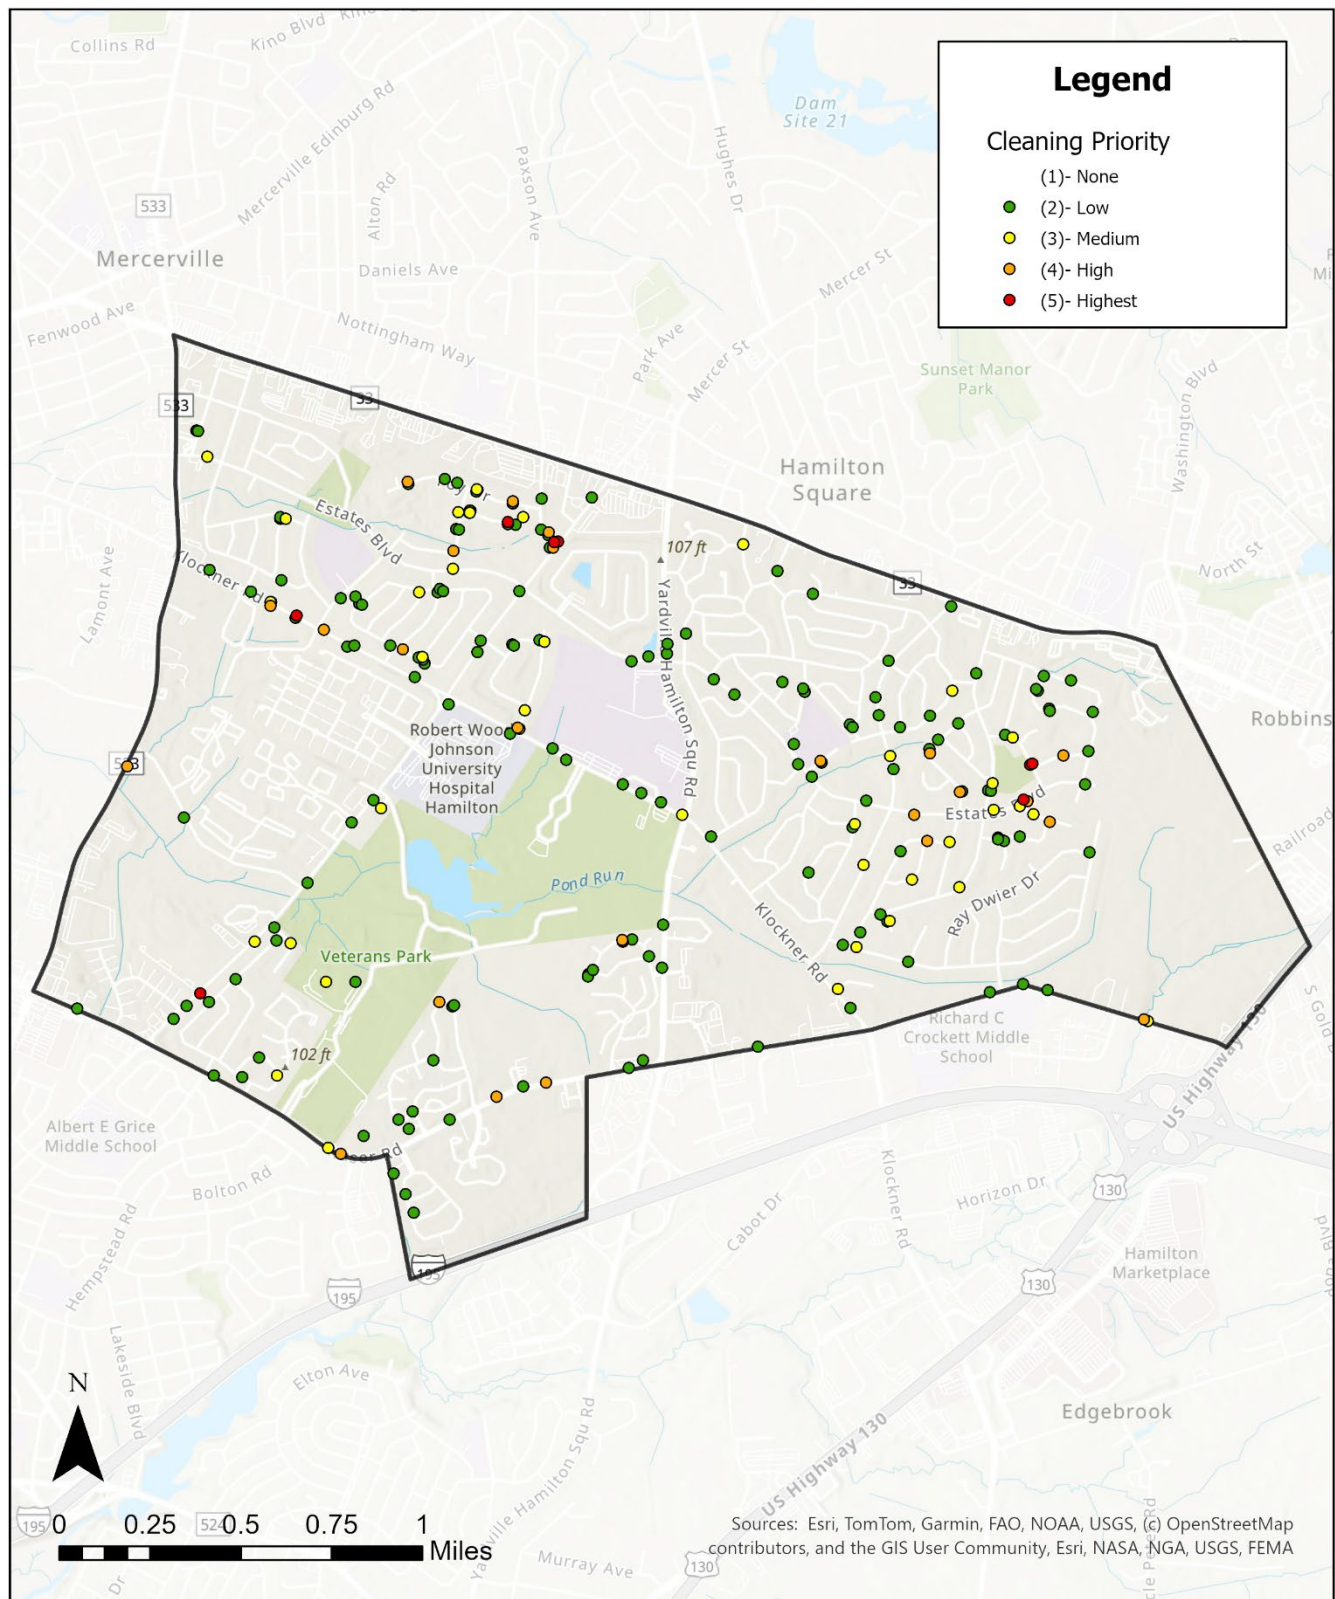
## 2026 Catch Basin Inspections: Cleaning Priority

The following conclusions were drawn after reviewing data for the 1,021 catch basins that were successfully assessed. Table 1 summarizes these findings. Based on medium being the action level, 73 catch basins are in need of cleaning, and 48 are in need of repair. For overall priority, there are 89 catch basins that are in need of attention first.

| | (1)-None | (2)-Low | (3)-Medium | (4)-High | (5)-Highest |
|---|---|---|---|---|---|
| Cleaning Priority | 797 | 151 | 40 | 24 | 9 |

1. The nine (9) catch basins identified as highest overall priority should be visited by Hamilton Township personnel, followed by the 19 high priority catch basins. A plan and schedule should be developed to take the necessary corrective actions as soon as possible.
2. A complete maintenance plan and schedule should be developed for all stormwater catch basins in Region 4 to address the deficiencies noted in this assessment in a timely manner starting with those with highest priority.
3. Each year, subsequent Regions should be inspected (Region 5 in 2027, Region 1 in 2028, etc.).

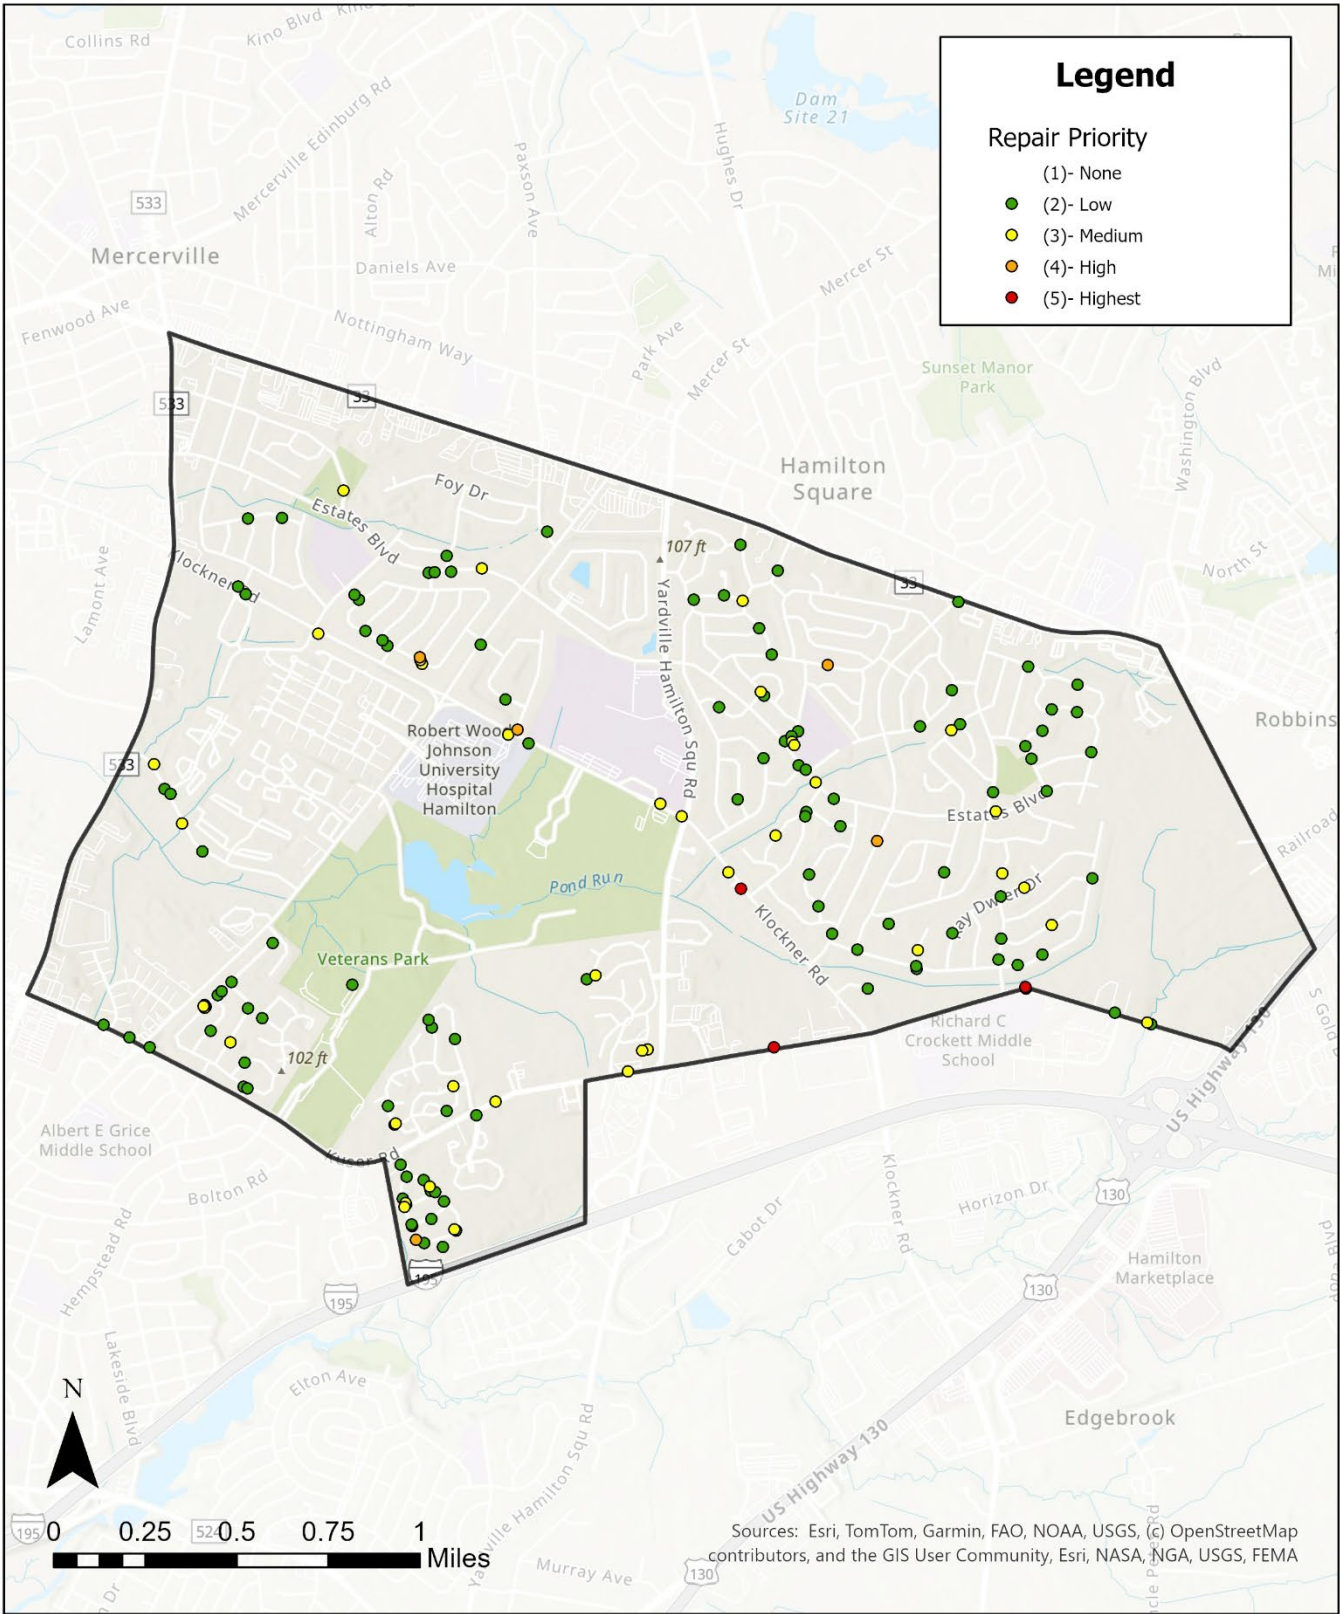
# 2026 Catch Basin Inspections: Repair Priority

| | (1)-None | (2)-Low | (3)-Medium | (4)-High | (5)-Highest |
|---|---|---|---|---|---|
| Repair Priority | 865 | 108 | 40 | 5 | 3 |

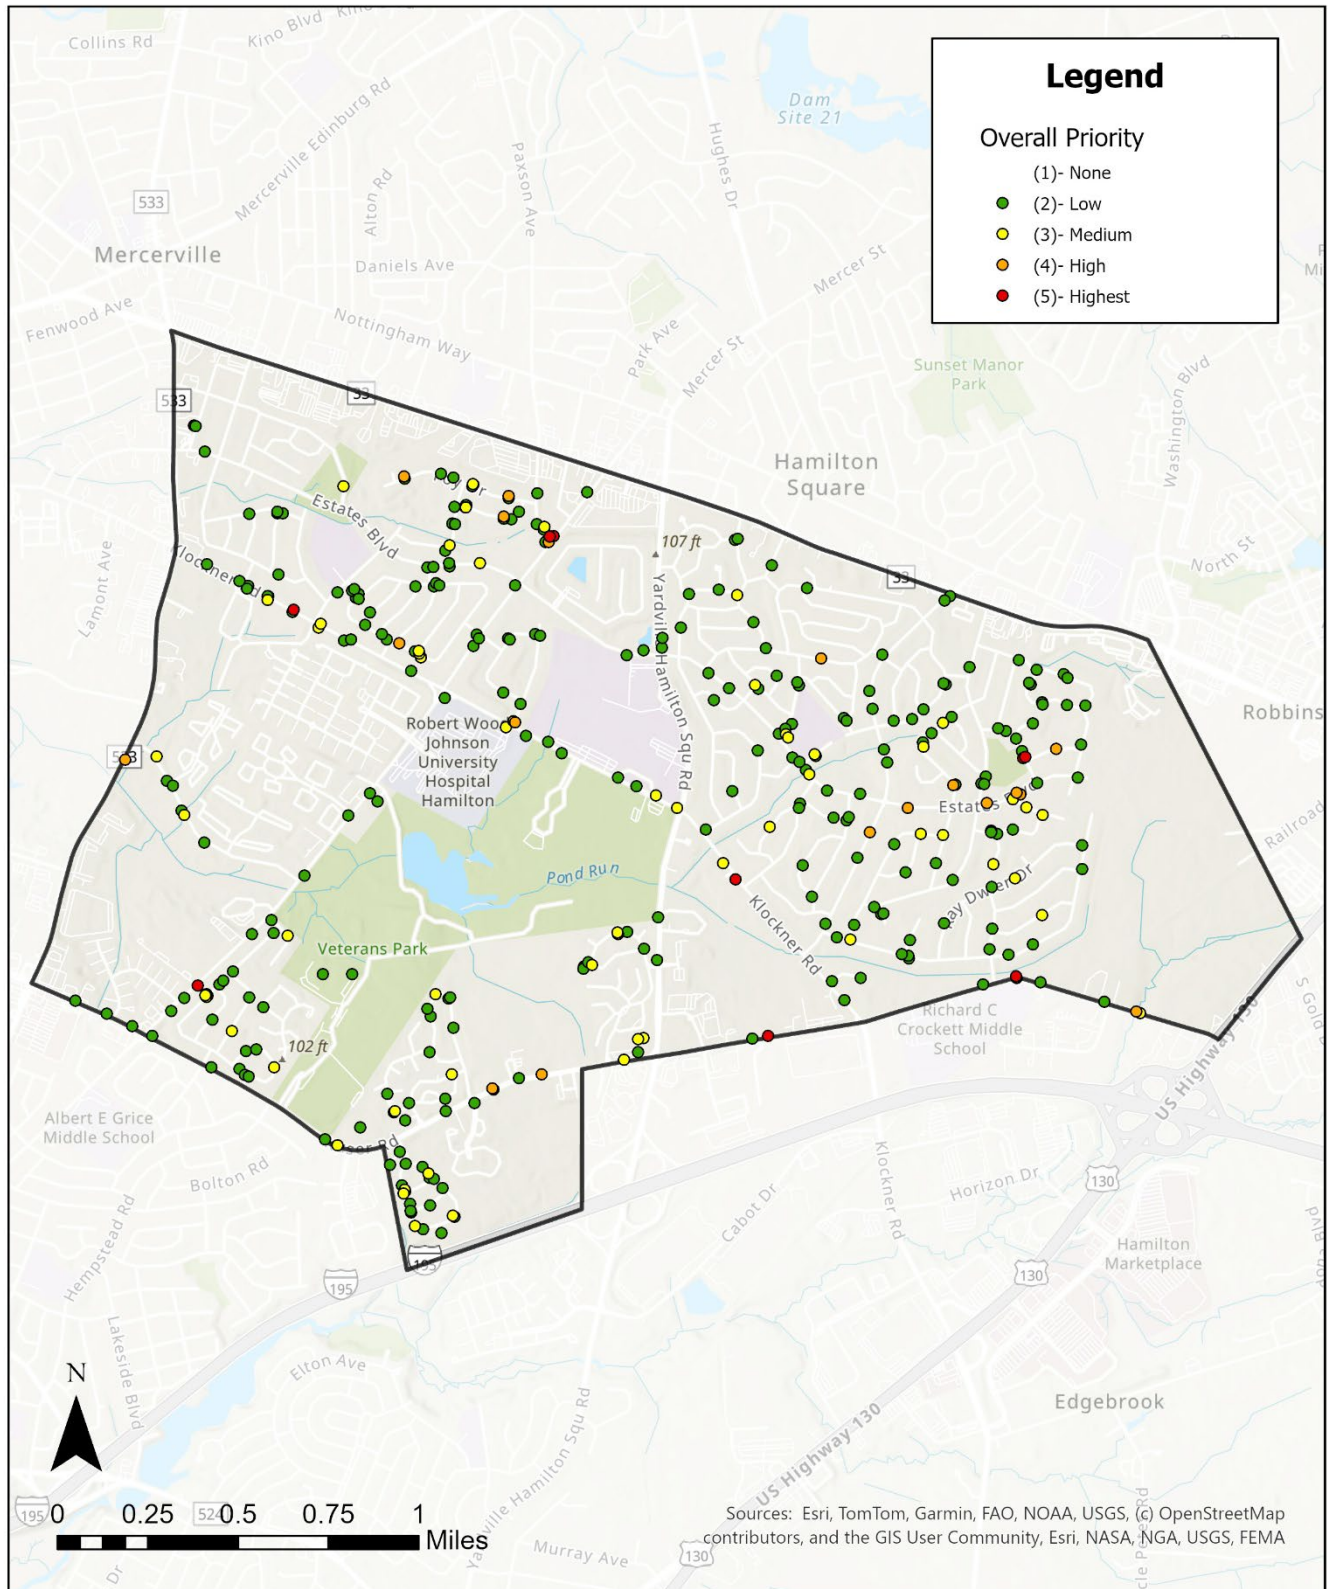
## 2026 Catch Basin Inspections: Overall Priority

| | (1)-None | (2)-Low | (3)-Medium | (4)-High | (5)-Highest |
|---|---|---|---|---|---|
| Overall Priority | 672 | 260 | 61 | 19 | 9 |

A series of maps is shown in Attachment 1 to show the spatial distribution of the priority criteria assigned to the catch basins inspected by the RCE Water Resources Program. A series of tables is provided in Attachment 2 to highlight each priority criterion as well as identify catch basins that were inaccessible, could not be found, or should be removed from the dataset. Catch basins inspected by the DPW in Snow Zone F are not included in either attachment. The full dataset with images of each catch basin can be viewed through the TRAISR application. The TRAISR dataset can be filtered and sorted with these criteria to navigate the data more easily than the static tables.
